Accident Investigation/Mine Fire Report
Underground Coal Mine

Mine Fire Investigation
April 10, 2003

Island Creek Coal Company
VP No. 8 Mine
Mine Index No. 08776AC
Buchanan County, Virginia

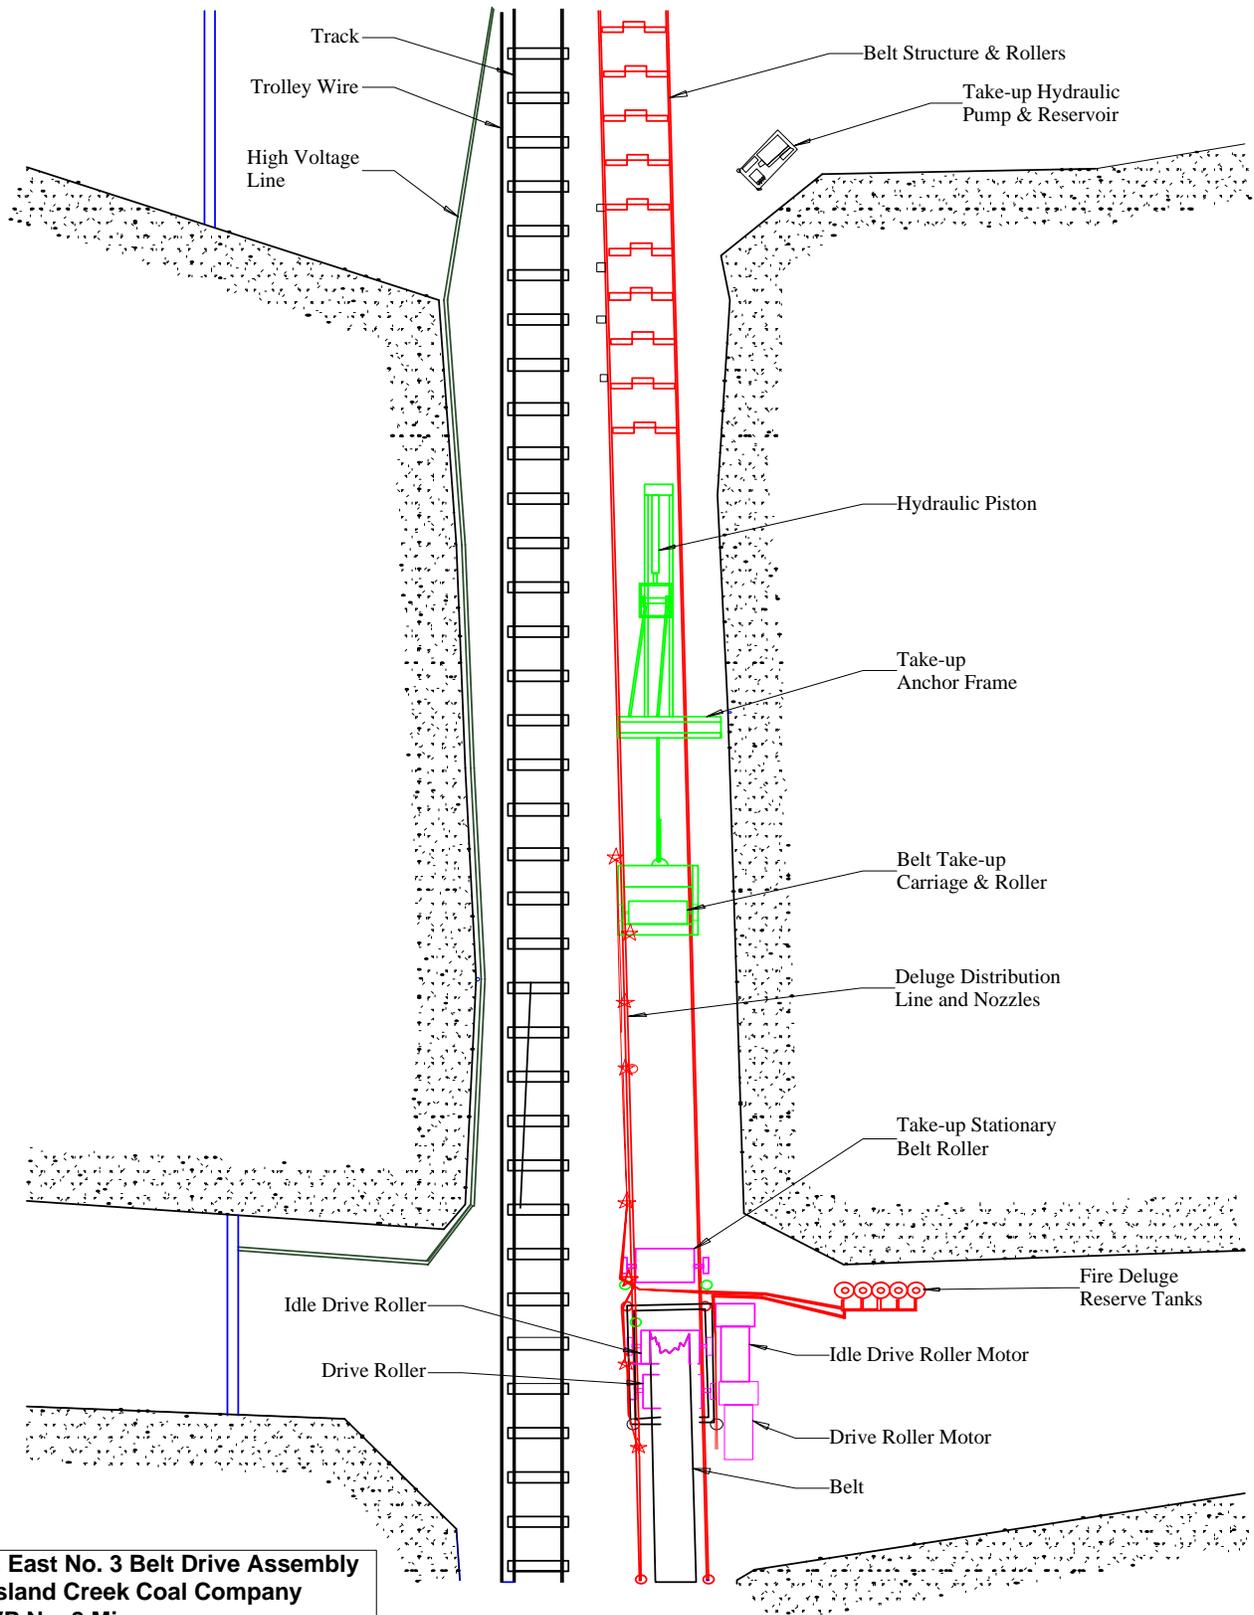
2 East No. 3 Belt Drive Assembly
Island Creek Coal Company
VP No. 8 Mine
M.I. No. 08776AC
April 9-10, 2003

FIRE IGNITION POINT
2 East No. 3 Belt Drive
